**AN
ENVIRONMENTAL REVIEW
OF THE
PROPOSED RETURN
OF
U.S. AIR FORCE LEASED PROPERTY,
ASCENSION AUXILIARY AIRFIELD
TO
THE BRITISH GOVERNMENT**

Tim deGavre
Computer Sciences Raytheon

March 26, 2004

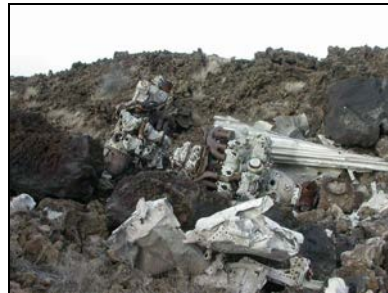
Approximately 200’ beyond the end of the runway at 7° 58.593’ S, 14° 22.869’ W, there are parts of a plane. Though several small pieces of aluminum framing and structure are scattered about, the larger remains consist of two aircraft engines, one with part of its propeller attached. The propellers are four-bladed. The aircraft type is not known, though it is suspected to be of World War II vintage.

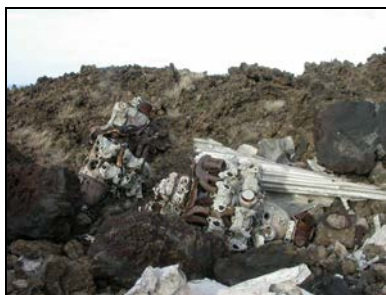
Strips of material, which definitely appear to contain asbestos, were noted on the cowlings of one of the two engines from the aircraft wreck, discussed in Section 3.2.5, Historical and Archeological above.

3. Hazardous Waste. Because runway inspectors or security and maintenance personnel would not normally be anywhere near the telephone poles or the aircraft wreck located among the volcanic rocks along the runway, and because of the lack of any fauna in this inhospitable area, it is highly unlikely that the hazardous substances (the creosote in the pole and the asbestos in the aircraft wreck) would cause harm to human or animal life; consequently, it is recommended that they remain in situ. However the aircraft wreck, being classified as an historical site which may prompt the curious to examine it, should

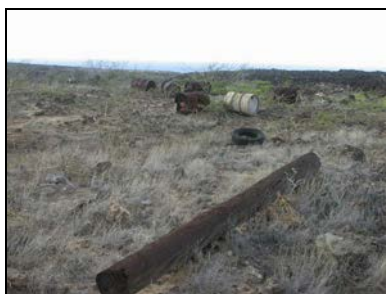
Three abandoned telephone poles, one on the north side of the runway in a gully at approximately the 8,500-foot point, along with several rusted drums, and two poles on the opposite side in a ravine at approximately the 9,500 foot point, have been impregnated with creosote.

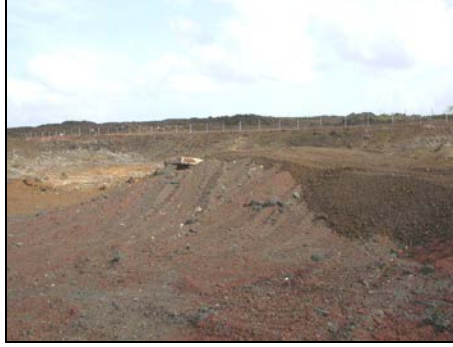
There are two 25,000 gallon and one 10,000 gallon asphalt-filled tanks buried at 7° 57.775' S, 14° 24. 206' W. These were buried in 1997 because the asphalt had hardened, making it unusable and the tanks too heavy to lift to transport.

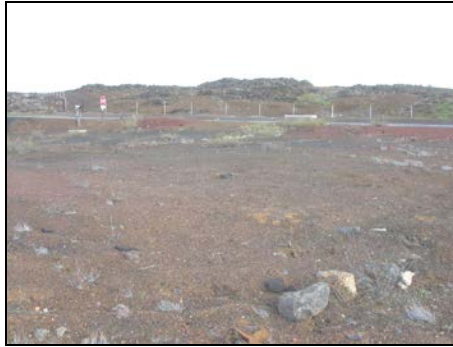
There are also two abandoned 10,000 gallon tanks from World War II buried at 7° 57.765' S, 14° 24. 276' W; they were partially filled with asphalt when they were buried.

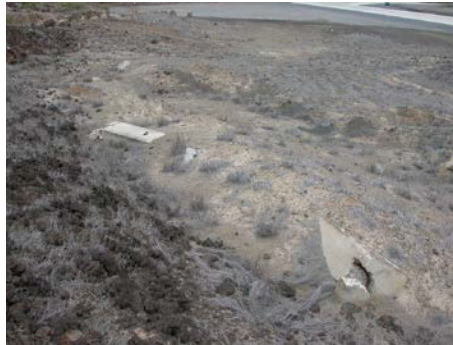
- a. At the base of the small hill near the 6,500 foot point on the north side of the runway are several very large concrete blocks, possibly bases for antennas.

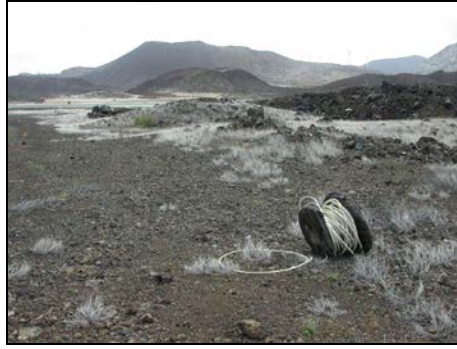
- c. Near the 7,800 foot point and at the base of South Gannet Hill, there is a medium-sized cable reel with several feet of electrical cable on it. Because the reel is in poor condition, it is suspected that it may have rolled down the hill during construction of the Telemetry Site.

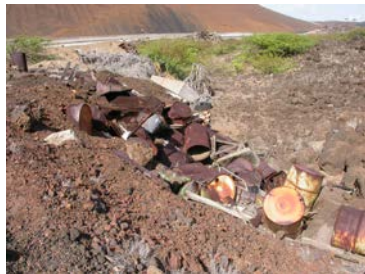
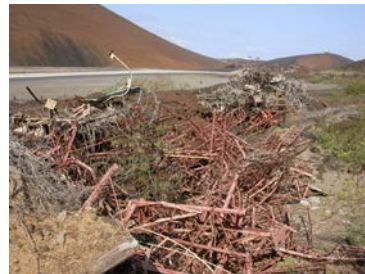
Outside the fence line near the end of the runway, there is an extensive dump containing an old rock-crusher, vehicles, equipment, antenna towers, etc. It is known as the South Africa Dump.

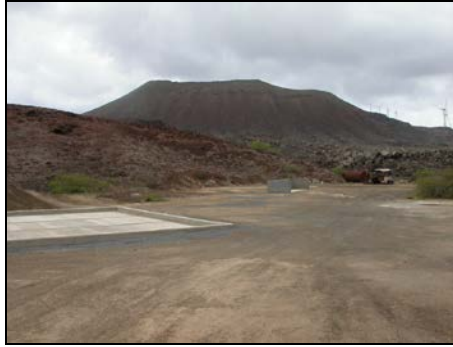
On the same side, at the 4,000 foot marker, is the RAF Burn Pit. Formerly the USAF Burn Pit, it has been expanded for training of the RAF and its contractor in fire suppression. It appears to be in good order.
